National Dam Inspection Program.
Upper Donohoe Dam (now Referred to as)
Twin Lakes Number 2 Dam, NDS I.D.
PA-00478), Ohio River Basin, Little
Crestree Creek, Westmoreland County,
Pennsylvania. Phase I Inspection
Report.

PHASE I REPORT
NATIONAL DAM INSPECTION PROGRAM

Upper Donohoe Dam: NDS I.D. No. PA-00478

Owner: Westmoreland County
State Located: Pennsylvania (PennDER I.D. No. 65-55)
County Located: Westmoreland
Stream: Little Crabtree Creek
Inspection Date: 13 December 1978
Inspection Team: GAI Consultants, Inc.
570 Beatty Road
Monroeville, Pennsylvania 15146

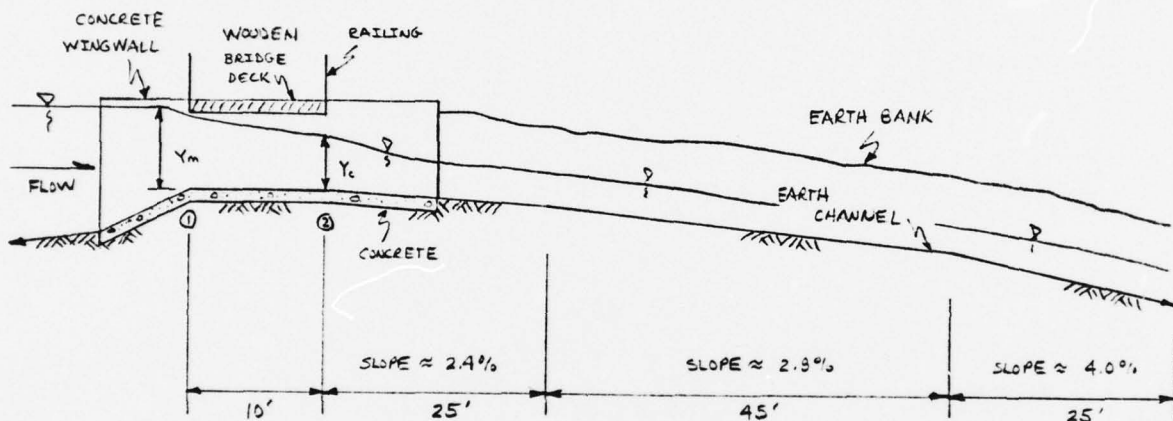
- PROFILE OF SPILLWAY : (NOT TO SCALE)

NOTE 7: SPILLWAY PROFILE SLOPES WERE MEASURED IN THE FIELD AS WERE THE LOW TOP OF DAM ELEVATION AND THE SPILLWAY OPENING DIMENSIONS.

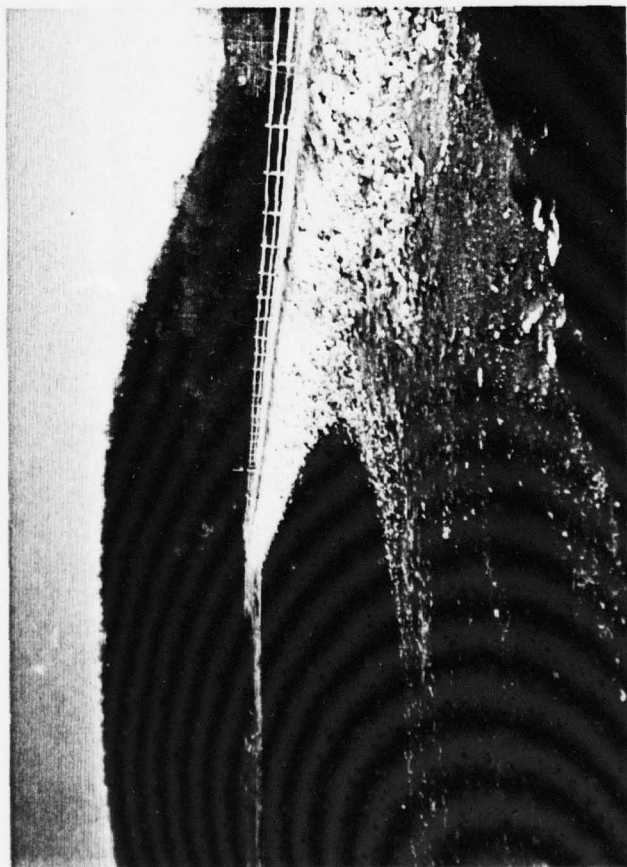
3

b. Embankment. The visual inspection indicates the embankment is in poor condition. Some seepage flow and localized saturated areas were observed along the downstream toe to the right of the valve house in spite of the drawn down status of the reservoir. Just to the right of the valve house, the outlets of two cast iron toe drain pipes were observed discharging about 2-3 gallons per minute from the left drain and approximately 5 gallons per minute from the right drain. A full evaluation of the quantity and extent of leakage could not be determined due to the drawn down condition of the reservoir at the time of the inspection (see Photograph 3).

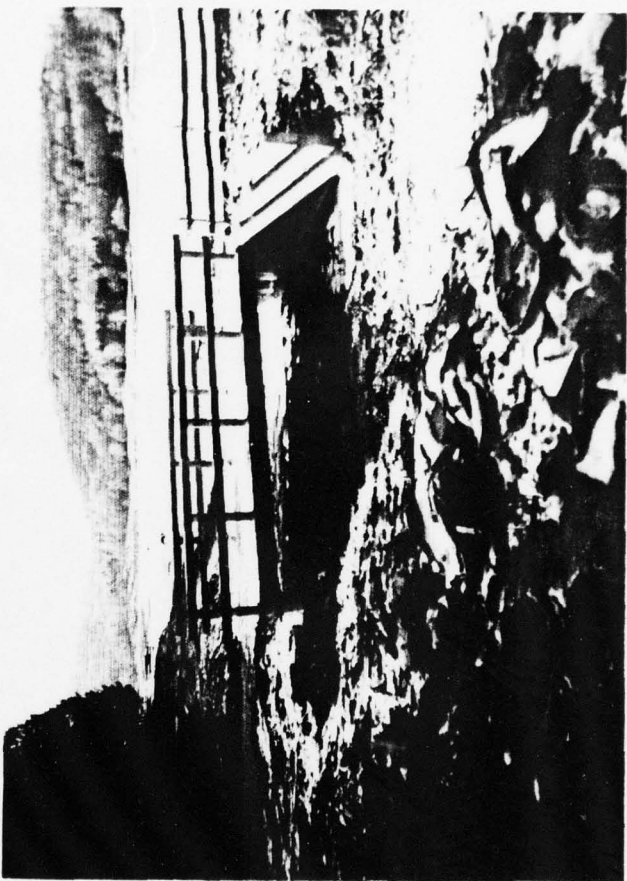
1. Spillway Structure. The spillway was completely reconstructed in 1977. Based on visual observations, the new spillway structure is in good condition (see Photographs 4 and 5).

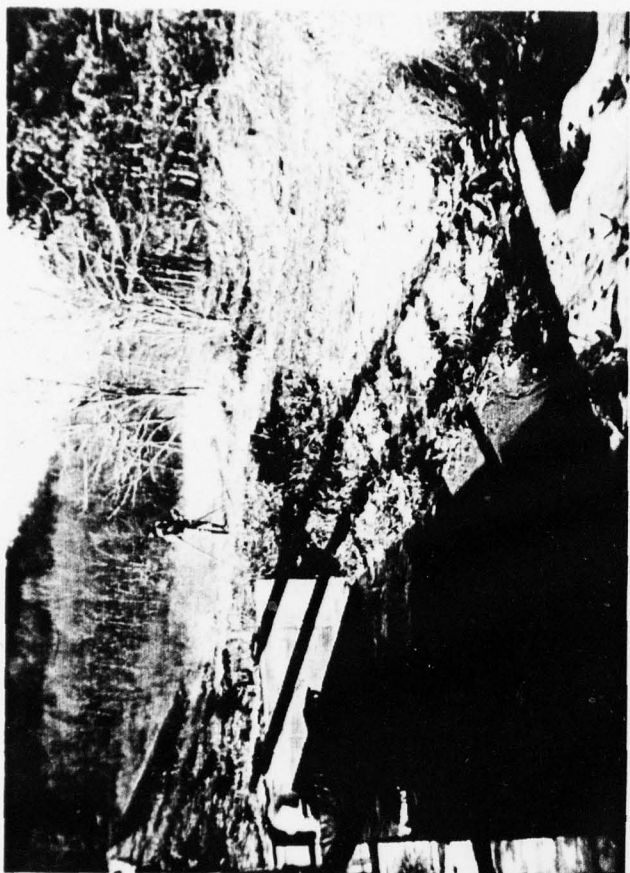
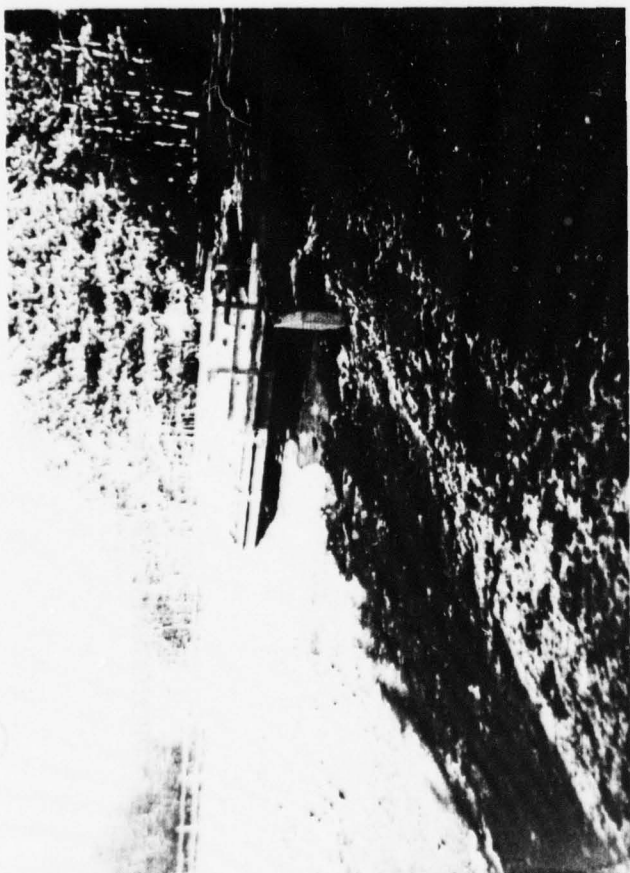
6

e. Downstream Channel. The concrete spillway structure discharges into a trapezoidal-shaped channel cut into natural ground on the right abutment (see Photograph 6). The channel is somewhat irregular with low and partially breached sidewalls on the downslope side. About 35 feet downstream of the spillway is a temporary construction road built across the channel. It is possible that modest discharges through the spillway could cause overtopping of the channel sidewall at the road crossing resulting in at least part of the flow being discharged near the toe of the dam. Approximately 250 feet downstream of the spillway, the channel discharges directly into the reservoir of Twin Lakes No. 1 Dam.

c. Remove the temporary earth road that presently crosses the discharge channel approximately 35 feet downstream of the spillway control. In addition, repairs to the breached left spillway sidewall at this location should be implemented. The thin layer of sediment lining the bottom of the concrete spillway channel should be removed.
